***2017 ASPECT Preliminary Report  
Arkema Plant Response  
Crosby, TX***

***September 1, 2017  
0500 hrs to ???? hrs***

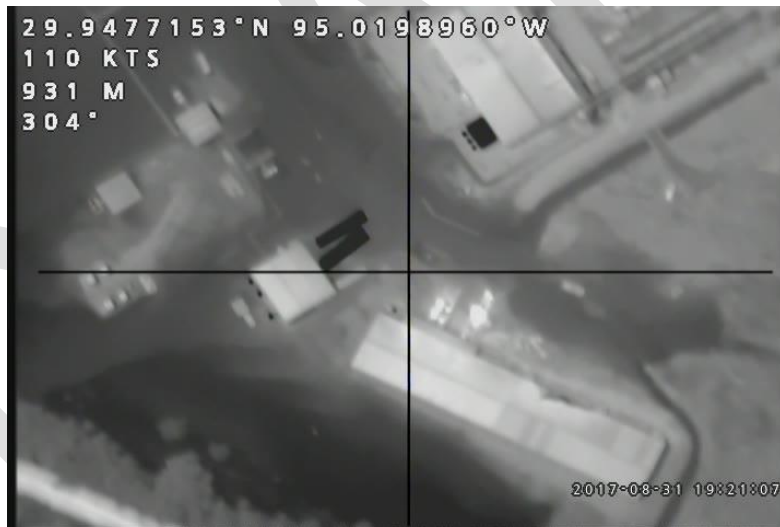
*Figure 1: Infrared Image of two refrigerated containers at the Arkema Facility on 31 August 2017*
